EFFECT OF GIRDER DAMAGE ON THE STRUCTURAL BEHAVIOR OF SLAB-  
ON-GIRDER BRIDGES

A THESIS IN CIVIL ENGINEERING  
Master of Science in Civil Engineering

Sharjah, UAE  
June 2011

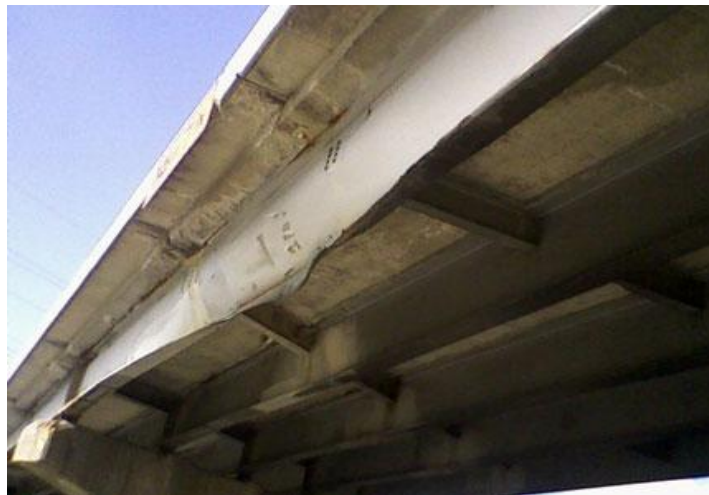
Fig. 1.1: Typical damage in a steel girder due to over-height truck impact [1]

There are various types of damage that a bridge can be subjected to during its lifetime, such as steel corrosion, concrete cracking, concrete spalling, fatigue, and fracture, to name a few. However, this study is concerned with structural damage to the supporting girders of a slab-on-girders bridge due to over-height truck impact, with particular attention to composite steel bridges. Figures 1.1 and 1.2 show respectively

typical damage in steel and prestressed concrete girder bridges due to over-height vehicle impact. The figures indicate that steel girders absorb the damage through ductile bend and distortion in the web and bottom flange, whereas concrete girders exhibit brittle concrete spalling and cracking in the bottom flange due to the imposed impact. In this context, the decision whether or not a damaged bridge can still hold the load of the traffic safely following damage to its girders is very sensitive. Often, the desire will be to determine the lost capacity or increased loading due to unforeseen redistribution of load in each structural element in order to repair it properly. One of the aims of this study is to determine change in the portion of the live load carried the critical bridge's girders resulting from damages in one of the girders, particularly the exterior one. As slab-on-steel girder bridges are very common structures around the world, this type of bridges is addressed in this study.

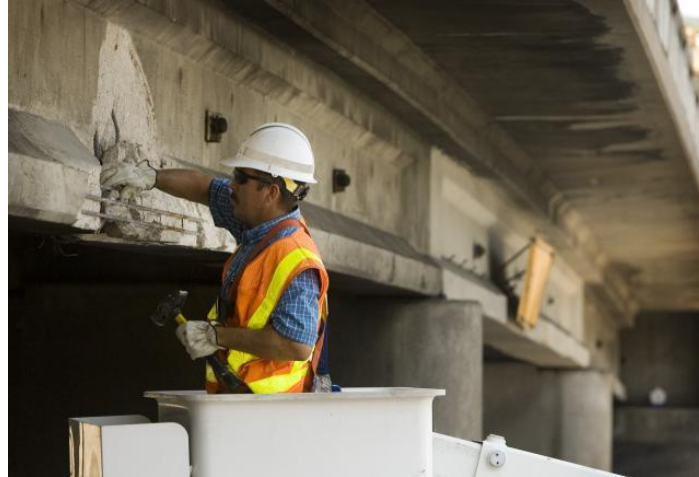
Fig. 1.2: Typical damage in a prestressed concrete girder due to over-height truck impact [2]

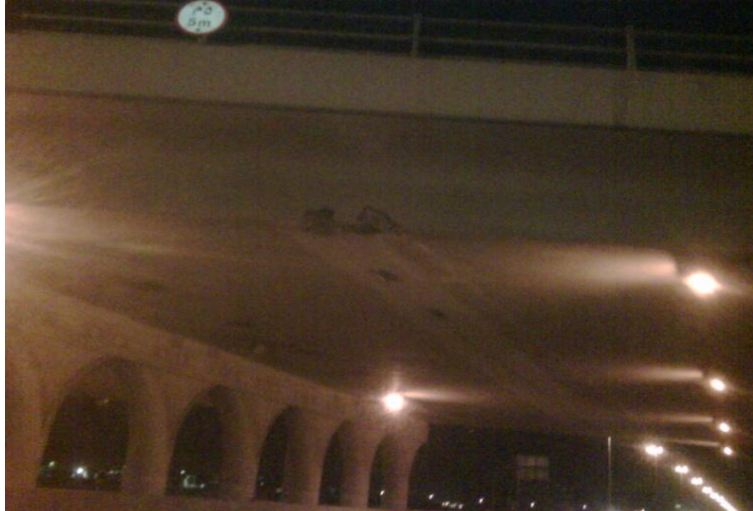
Fig. 1.3: Example of minor damage of a bridge in UAE (photo taken by author)

In some cases, such damage can be minimal and the bridge capacity is retained to a close level to that of the as-built capacity of the bridge. In these cases, the rectification work required can be deferred to a later time or can be done along with the normally planned prevention maintenance regimes. Figure 1.3 shows a posttensioned concrete box girder bridge in the UAE that has experienced minor damage due to an over-height truck scraping the bottom of the bridge.

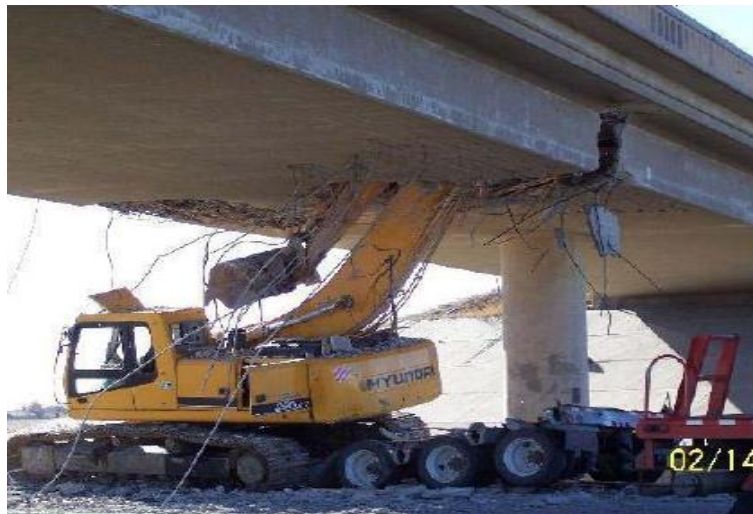
Fig. 1.4: Example of severe damage of a bridge [3]

However, in other cases, such damage can be so severe that they reduce bridge capacity and need to be immediately rectified since they drastically decrease the structural safety. Figure 1.4 shows an example of severe damage in a bridge hit by an over-height crane while moving under the bridge. When the damage is severe, it affects the primary load bearing elements and can, in some cases cause collapse especially to non-redundant bridges composed of a few girders.

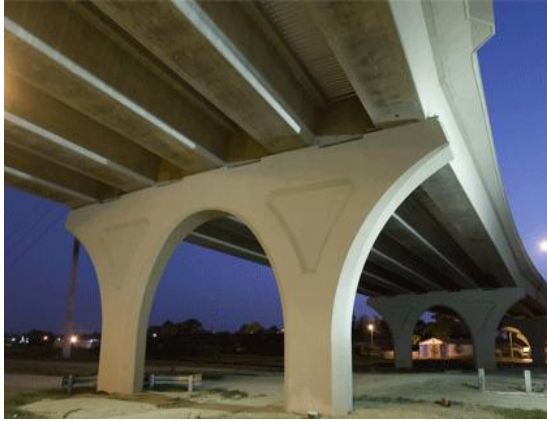
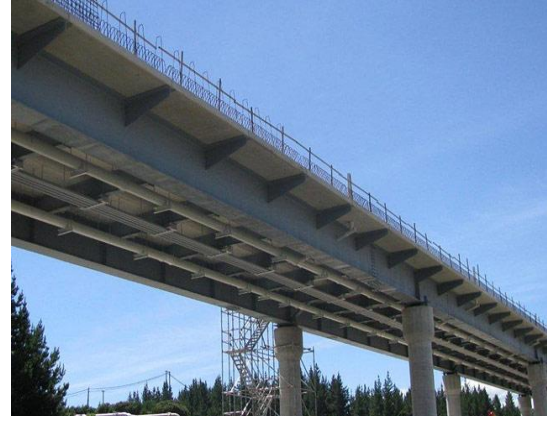
(a) Concrete girders

(b) Steel girders

Figure 2.3: Examples of slab-on-girder bridges [7]

Composite steel girder bridges provide advantages over other types in terms of decreased weight, reduced cost, and enhanced performance. They provide superior stiffness to weight ratio; delivering 25-30% reduction in weight compared to other steel beams of similar stiffness and strength. The significant reduction in weight results in less material being used, reduced deflection, and decreased load effects (shear and bending moment) in the structural elements compared to other types of beams. Other advantages of steel bridges include their ability to maintain their strength with time, prefabrication, versatility in construction, and recyclability. Their main disadvantages are their need for protection against corrosion, high conductivity of temperature, susceptibility to fatigue and fracture. Figure 2.3 shows examples of slab-on-girder bridges.

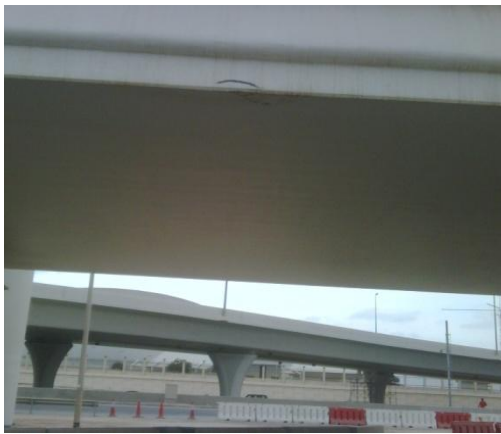
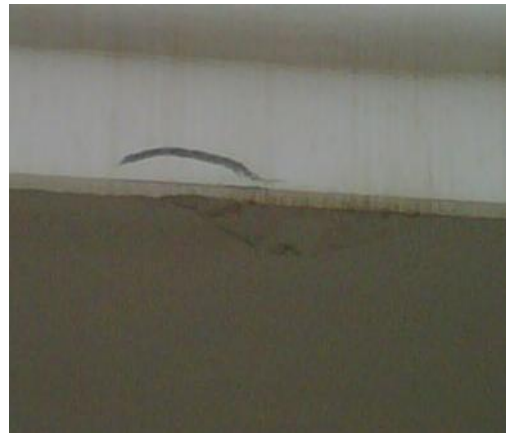
Figure 2.6: Dubai Metro Bridge in Rashidiya, Dubai, UAE (photos taken by author)

It was expected that records on over-height vehicle collision with bridges would not be available for countries like the UAE, as such incidents might be rare since most bridges in the country are relatively new and constructed with ample vertical clearance according to the specification. A limited field observation in Dubai and Sharjah has revealed that such accidents have happened recently in the cities with an increasing frequency. Figures 2.6, 2.7 and 2.8 show some examples of the observed over-height vehicle collision with concrete bridges in the UAE. Although the limited local study showed that the extent of the damage in these examples is minimal, it was observed that repair work was not carried out on the affected bridges.

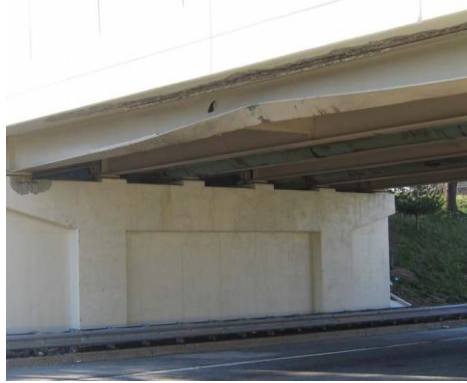
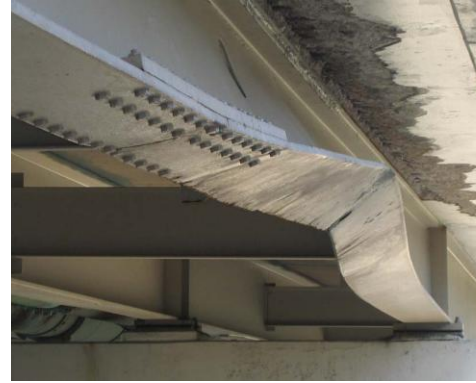
Figure 2.9: Exterior Girder in the 10<sup>th</sup> Street Bridge on the Interstate Route 95 in Delaware Damaged Due to an Over-Height Vehicular Collision [1]

Literature and statistical information has minimal record on the mode of damage in girders struck by over-height vehicles. Few studies recorded the mode of damage in such accidents such as the study conducted on the 10<sup>th</sup> Street Bridge on the Interstate Route 95 in the state of Delaware in the United States [1]. In this case, an over-height vehicle hit the bottom of the exterior composite steel girder. The girder was bent about the web while the flange suffered minor buckling. One of the diaphragms was almost separated from the girder. The above damage is shown in figure 2.9. The figure shows that the girder is locally bent about the web along the span of the girder, within the middle-third of the span length.

The same study recommends evaluating the retained capacity in the damaged girder by calculating second moment of inertia for the deformed cross-section and establishing the new capacity accordingly. However, it was proven by Bedi [26] that the reduction in the actual section load carrying capacity for a damaged girder is almost double the reduction obtained by computing the modified cross-section properties. Hence, relying on damaged girder cross-section geometrical properties to evaluate the load carrying capacity after damage overestimates the structural capacity of the damaged section.

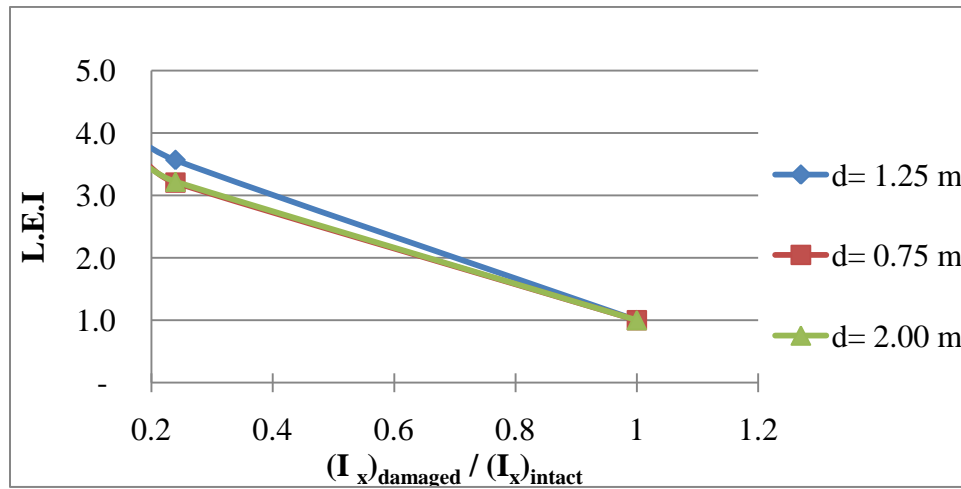
Figure 5.59: L.E.I for damaged girder in bridges 10, 1 and 11 (slab overhang width parameter)
